# Future Directions for the Inspection of CASS

## Summary Report

### 2<sup>nd</sup> International Workshop on the Future Directions for the Inspection of Cast Austenitic Stainless Steel Piping

June 15 -16, 2009  
Seattle, WA

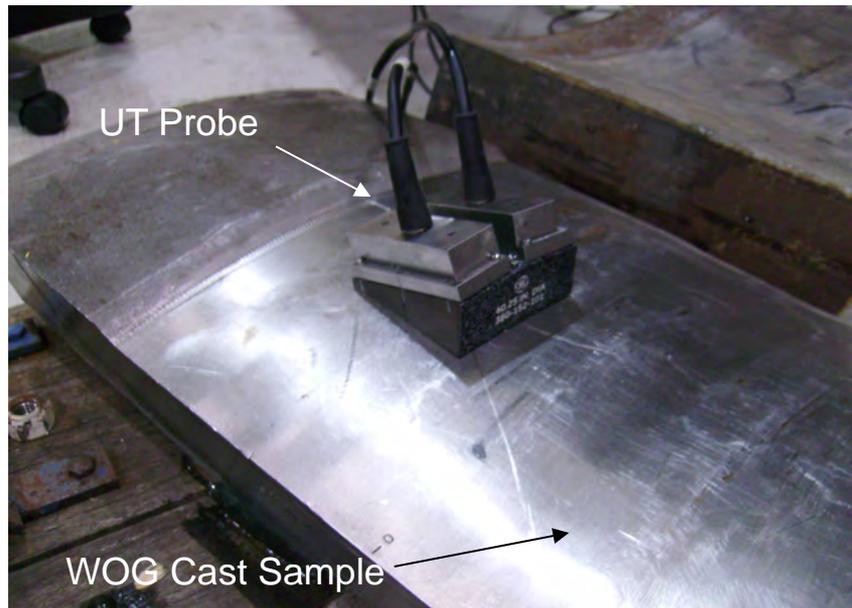
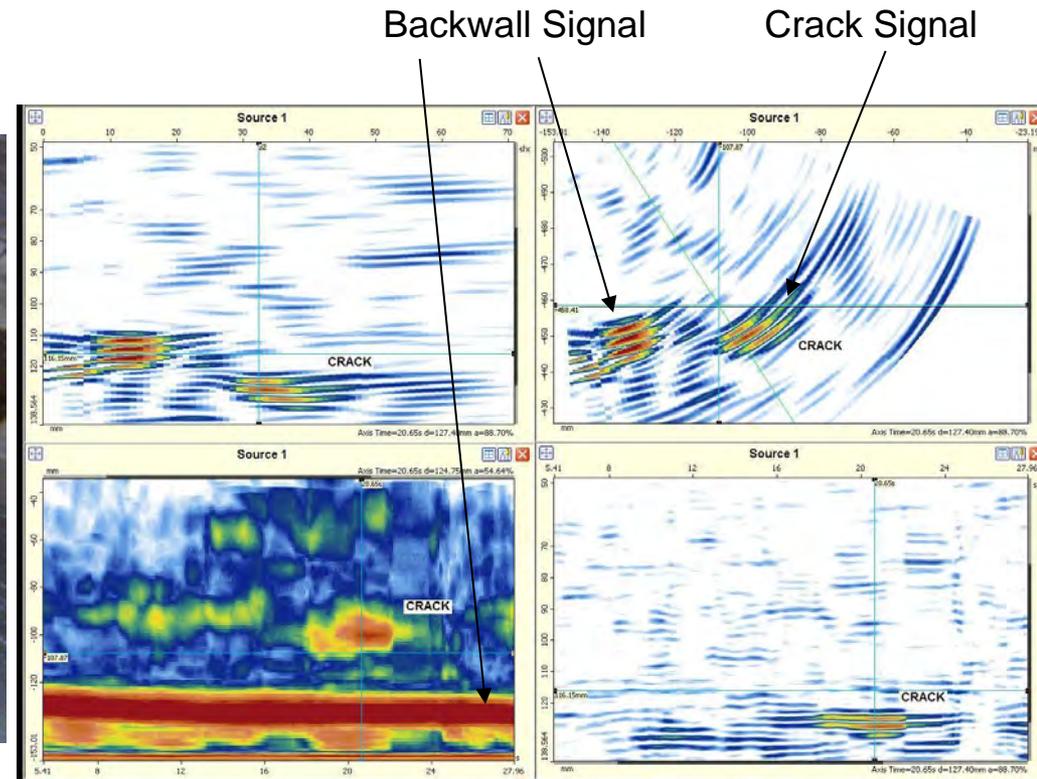
- Obtained Ultrasonic Phased Array Data using Low Frequency Probe (500 kHz) on WOG Cast Stainless Steel Sample containing Inside Surface Connected Circumferentially Oriented Crack

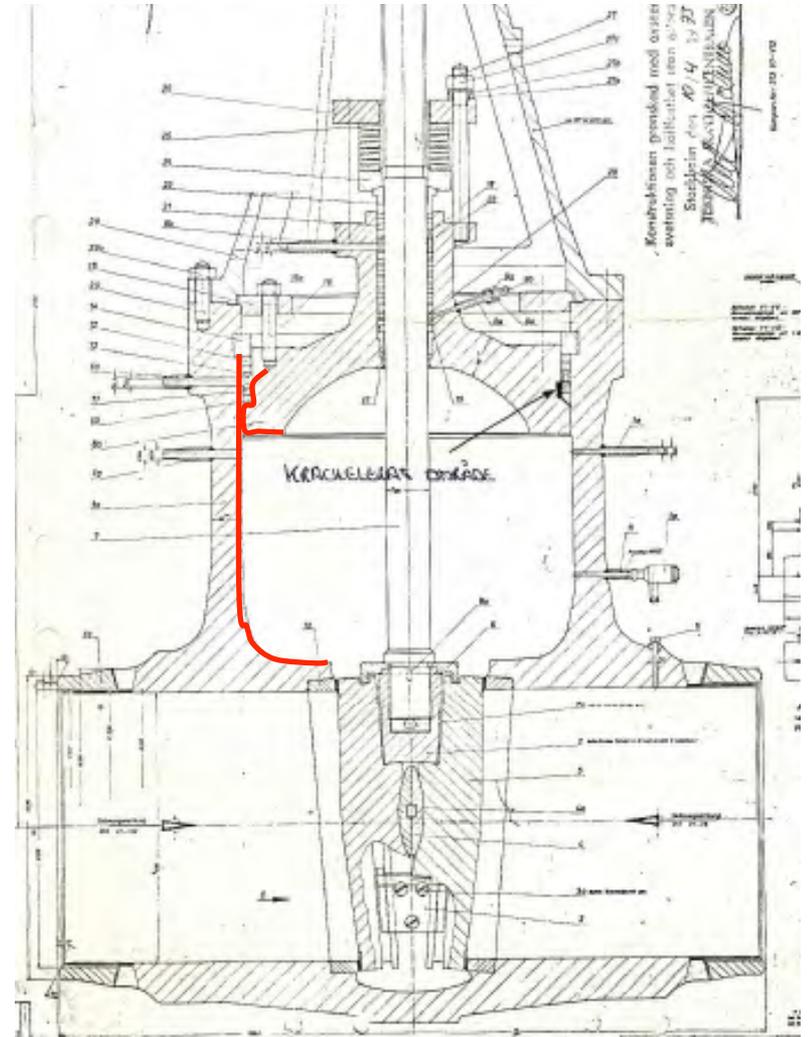
# Ringhals 1 – MCS Indications in valve house and valve plate 97

- Main Circulation System
  - KSB (“Bredtschneider”)
  - 1.4552 (CA, no Mo)
- VT of
  - Valve plate
    - Visible cracks!
  - Valve house
    - No visible cracks
- PT of Valve plate

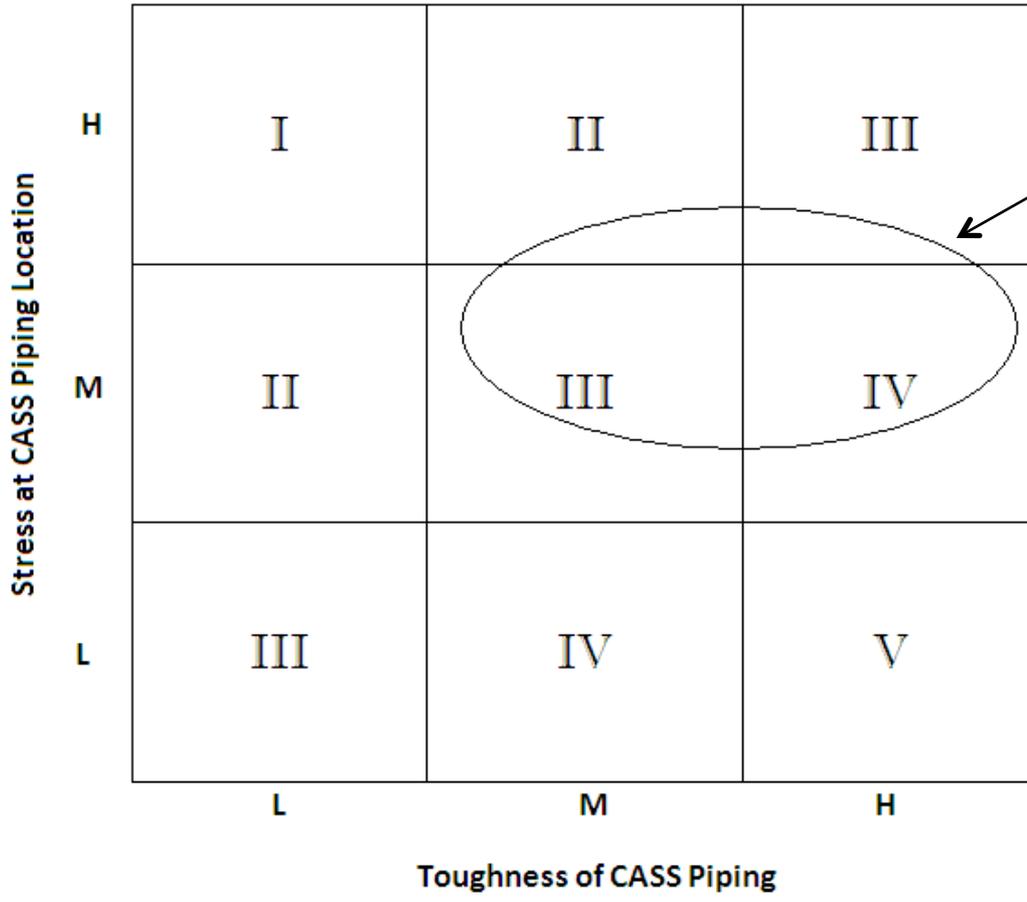
# Consider Relative Risk of Fracture (Including Uncertainties)

- Most plants initially would fall within a range of design stress and (unaged) material toughnesses shown by the oval region
- Characterizing risk equates to determining a safety margin

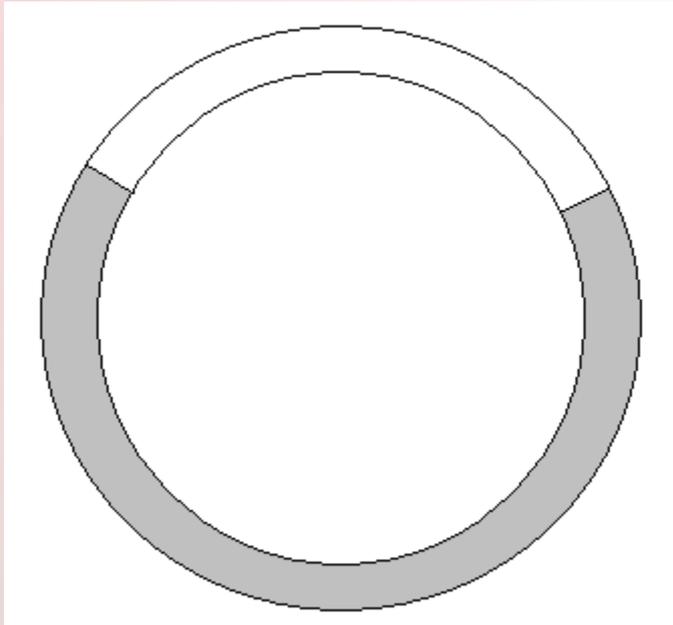
# Example of Critical Flaw Size in CASS Piping (Using S.F. = 1.0)

- Consider the maximum critical flaw size to be a through-wall flaw approx. 35% of the circumference
- The critical flaw size uses a safety factor of 1.0
- This is the flaw size that would be required to fail the pipe

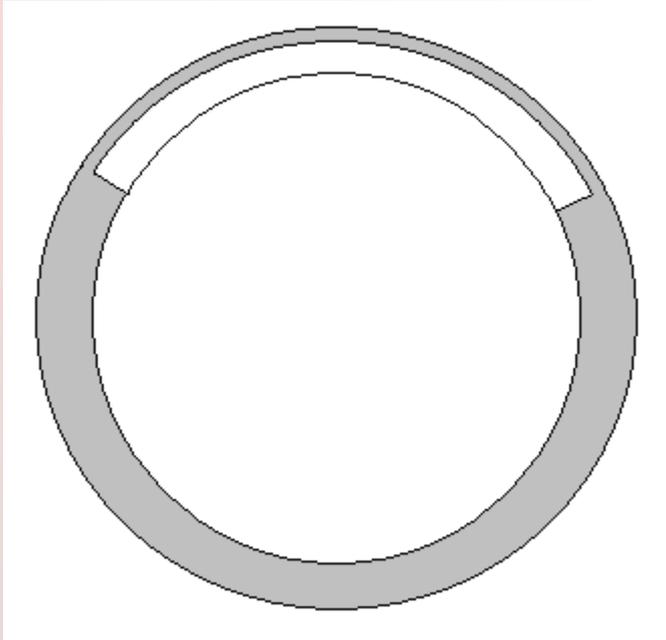
# Example of Maximum Allowable Flaw Size for a Category V Case

- Example showing the maximum allowable flaw size for the case of unaged or low delta ferrite CASS piping
- Maximum depth ( $a/t$ ) = 0.65 for a 35% circumference flaw

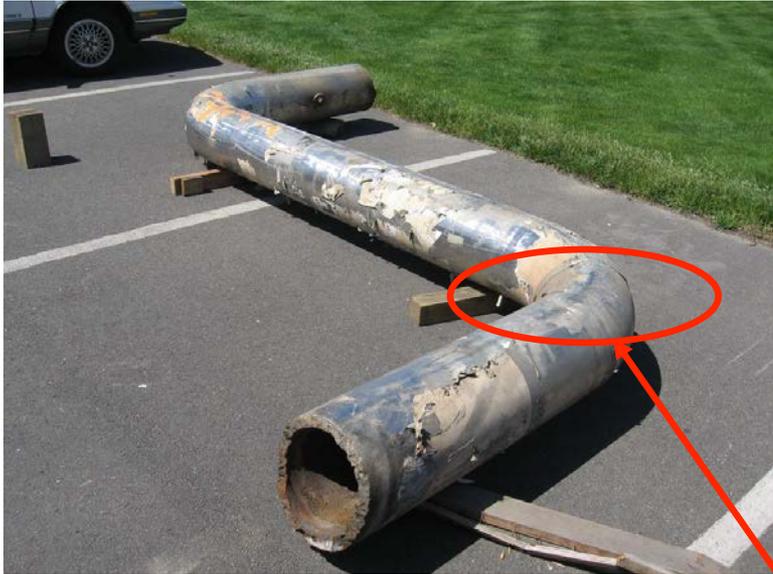
# PZR Surge Line Specimens (WNP-3)

**Microstructure of elbow  
segment from WNP-3 PZR  
surge line specimen  
34 - 44 mm (1.3 - 1.7 in.) wall**

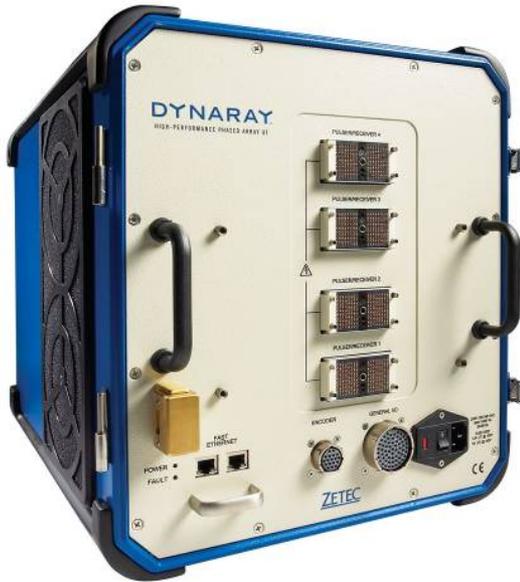
# Phased Array Data Acquisition System

**Dynaray® PA System**  
**0.2 – 20 MHz**  
**256 channels**  
**Ultravision® software**

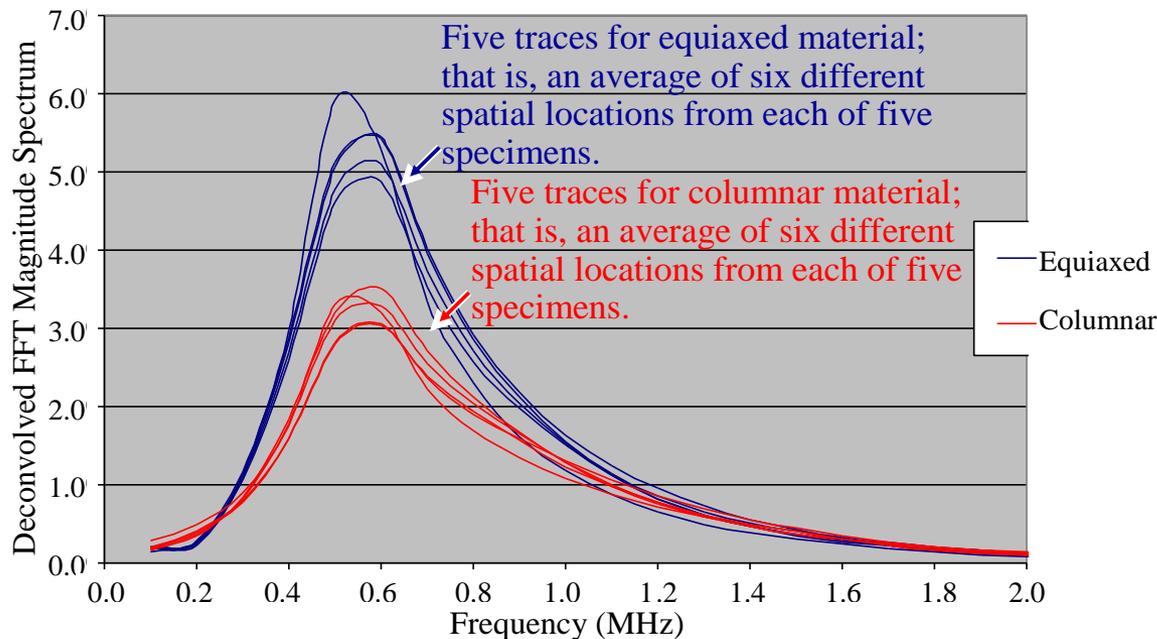
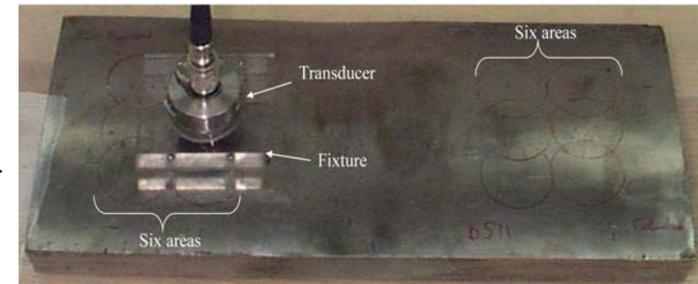
## Time-of-Flight Ratio Shear Wave to Longitudinal Wave Measurements

**10 Spatially Averaged, Deconvoluted FFT Magnitude Spectra Illustrating Difference between Data Obtained from Equiaxed Grain and Columnar Grain Microstructures**

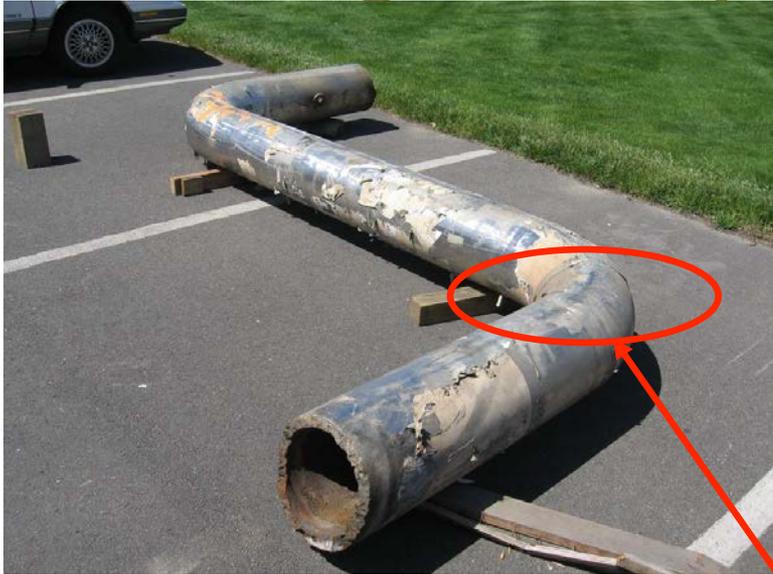
# PZR Surge Line Specimens (WNP-3)

**Microstructure of elbow  
segment from WNP-3 PZR  
surge line specimen  
34 - 44 mm (1.3 - 1.7 in.) wall**

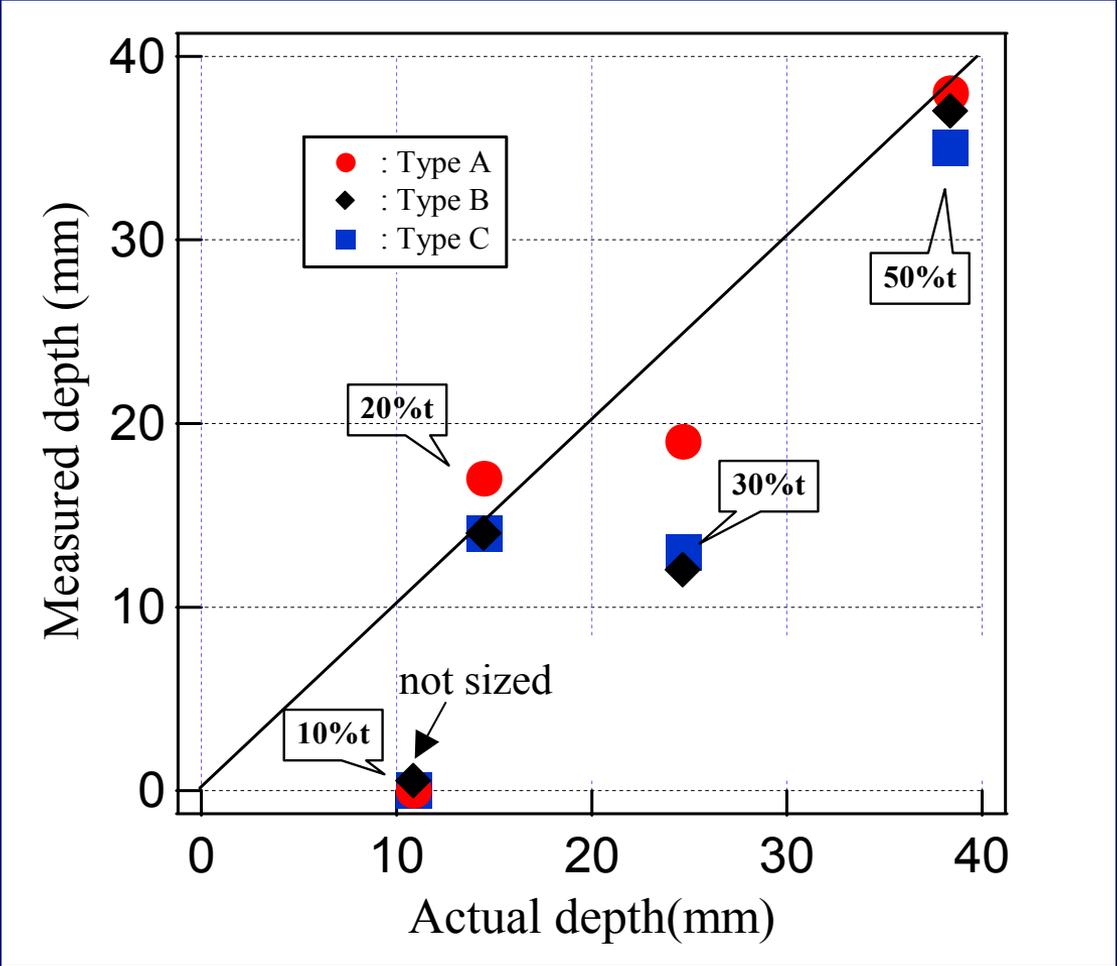
measured depth :  $70 - 33 = 37\text{mm}$  (actual depth 38.4mm)

**Fatigue cracks over 20%t could be sized.**

**Correlation coefficient : 0.88**
